# Soft Engineering for River Bank Stabilisation

Strule  
Catchment  
Story Map

Camowen River, Strule  
Catchment, Omagh

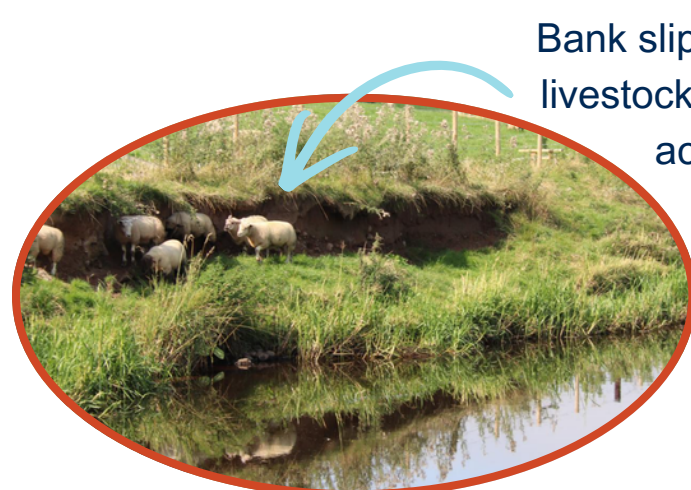
Bank slippage due to  
livestock and human  
access.

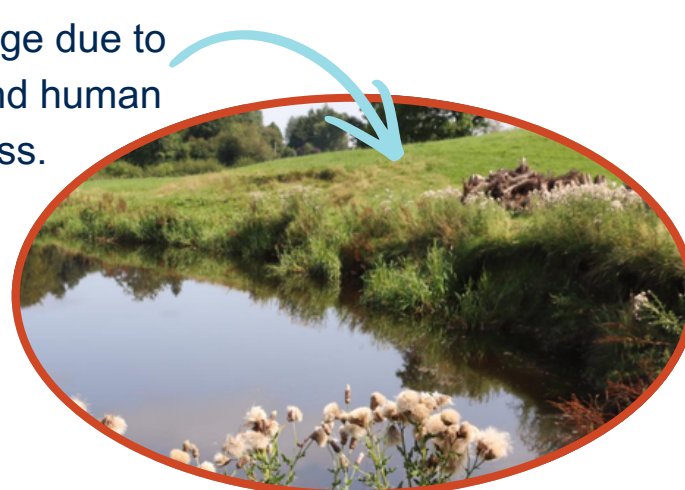
Locally sourced root  
wads catch silt travelling  
from upstream.

root  
wads

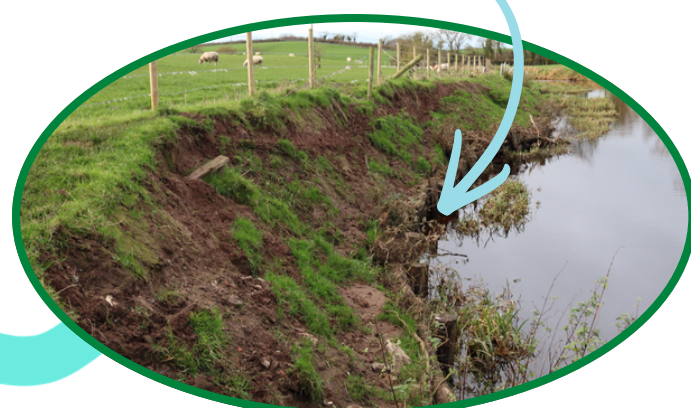
Timber piles driven in to stabilise  
the bank with brash piled behind  
to trap silt and debris.

larch timber piles  
with brash

The underlying geology can  
affect the ease of driving in  
vertical timber piles.
